**Town of Ludlow  
Engineering Needs  
Assessment Report  
February 23, 2018**

# 1 Executive Summary

## 2 Scope of inspections

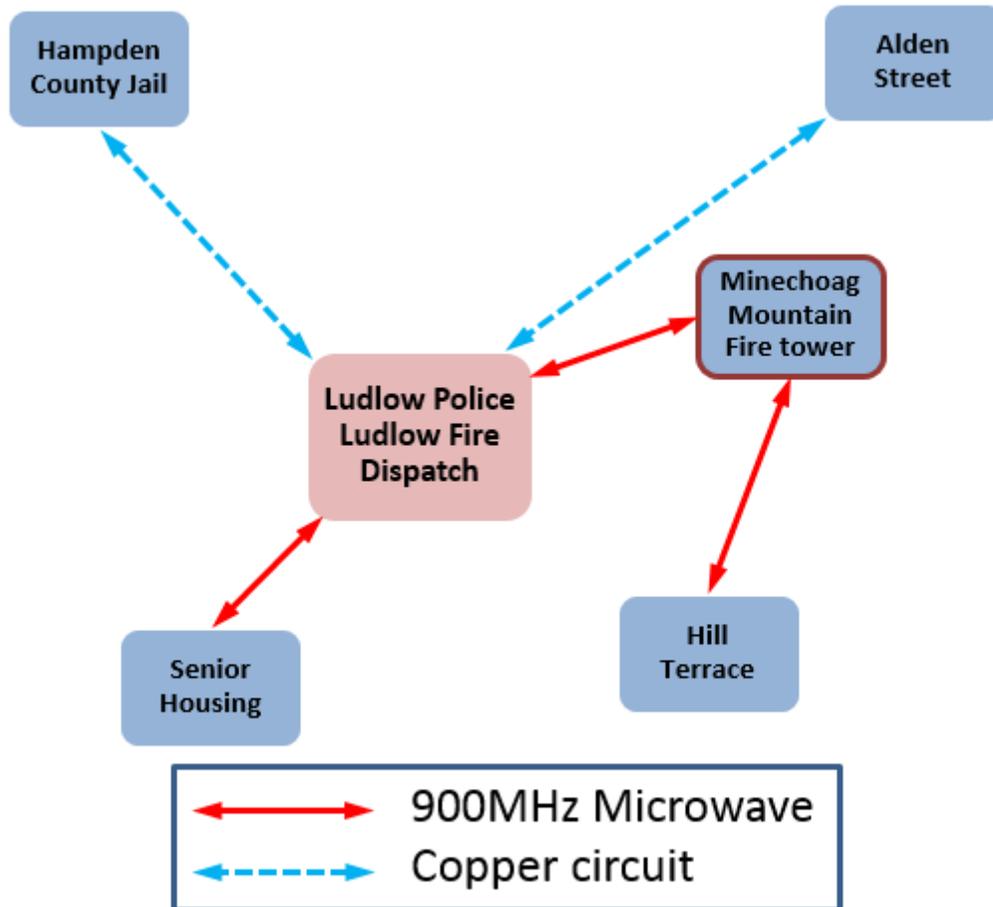
## 5.4 Ludlow Connectivity Plan

The connectivity between sites is established with MDS 900MHz licensed microwave radios. Microwave links connect between Ludlow Police headquarters, Minechoag Fire Tower, Senior Housing, and Hill Terrace. The two additional sites at the Hampden County Jail and Alden Street are connected by copper wireline circuits.
